PENOBSCOT RIVER BASIN  
SEBEC, MAINE

SEBEC DAM  
ME 00163

PHASE I INSPECTION REPORT  
NATIONAL DAM INSPECTION PROGRAM

JUNE, 1981

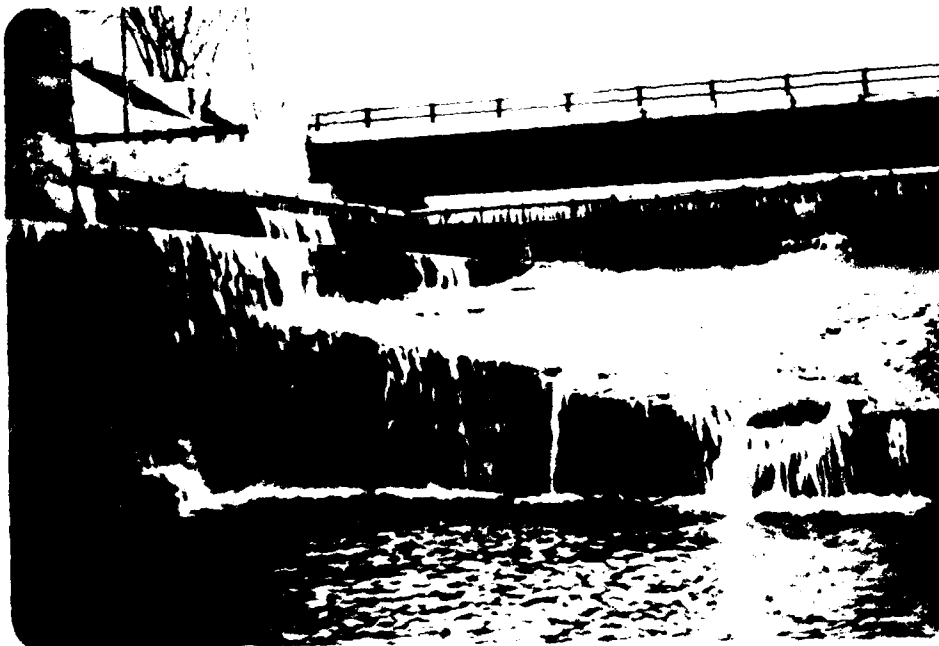
b. Dam - This is basically a timber crib, rock filled dam with concrete renovations and additions. The timbers have been capped with concrete to produce the spillway crest and apron as shown in Photos 1 and 2. As seen in Photo 2, there is a moderate amount of leakage from between some of the timbers of the crib. This was not considered indicative of any structural deficiency. Bedrock is exposed in the area of the right abutment as shown in Photo 3. The left abutment, shown in Photo 4, is concrete enclosed by steel sheet piling. Both the piling and the concrete abutment are in good condition. A stone riprapped slope goes from this abutment for some 30 yards upstream to the stub abutment of a highway bridge. This riprap is in good condition and extends up the slope to 3 feet above the water level on the day of inspection.

1. Rock-filled Timber Cribwork Visible Under Concrete

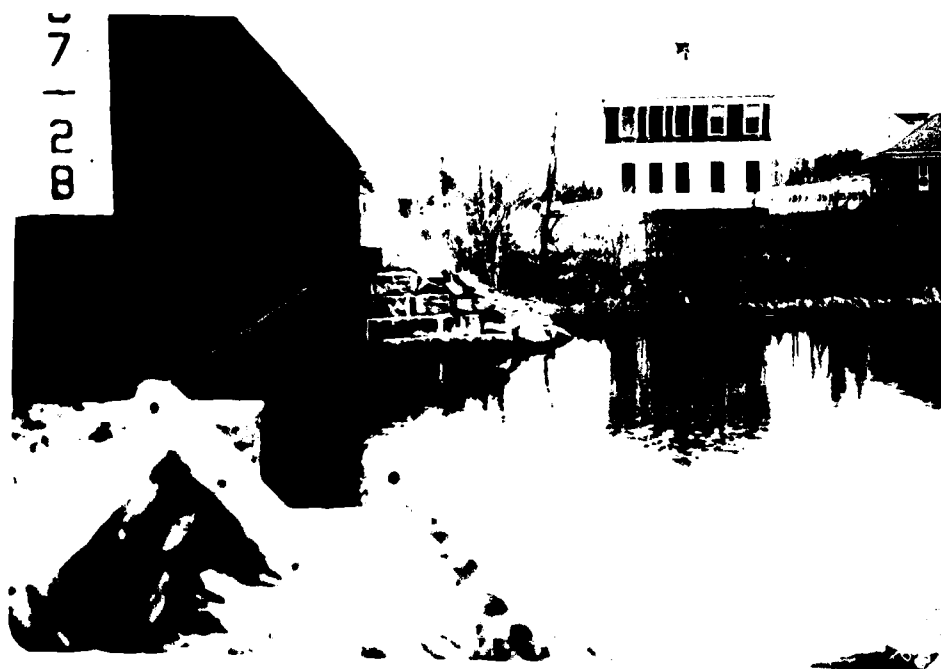
10. Railroad Bridge Crossing Sebec River In Milo.
